The diagnostic challenge of vertical root fracture in endodontically treated teeth: A case report

Purpose: To present the diagnostic challenge of a clinical case of vertical root fracture (VRF) in an endodontically treated mandibular left lateral incisor and discuss the diagnostic methods employed to achieve the conclusive diagnosis.

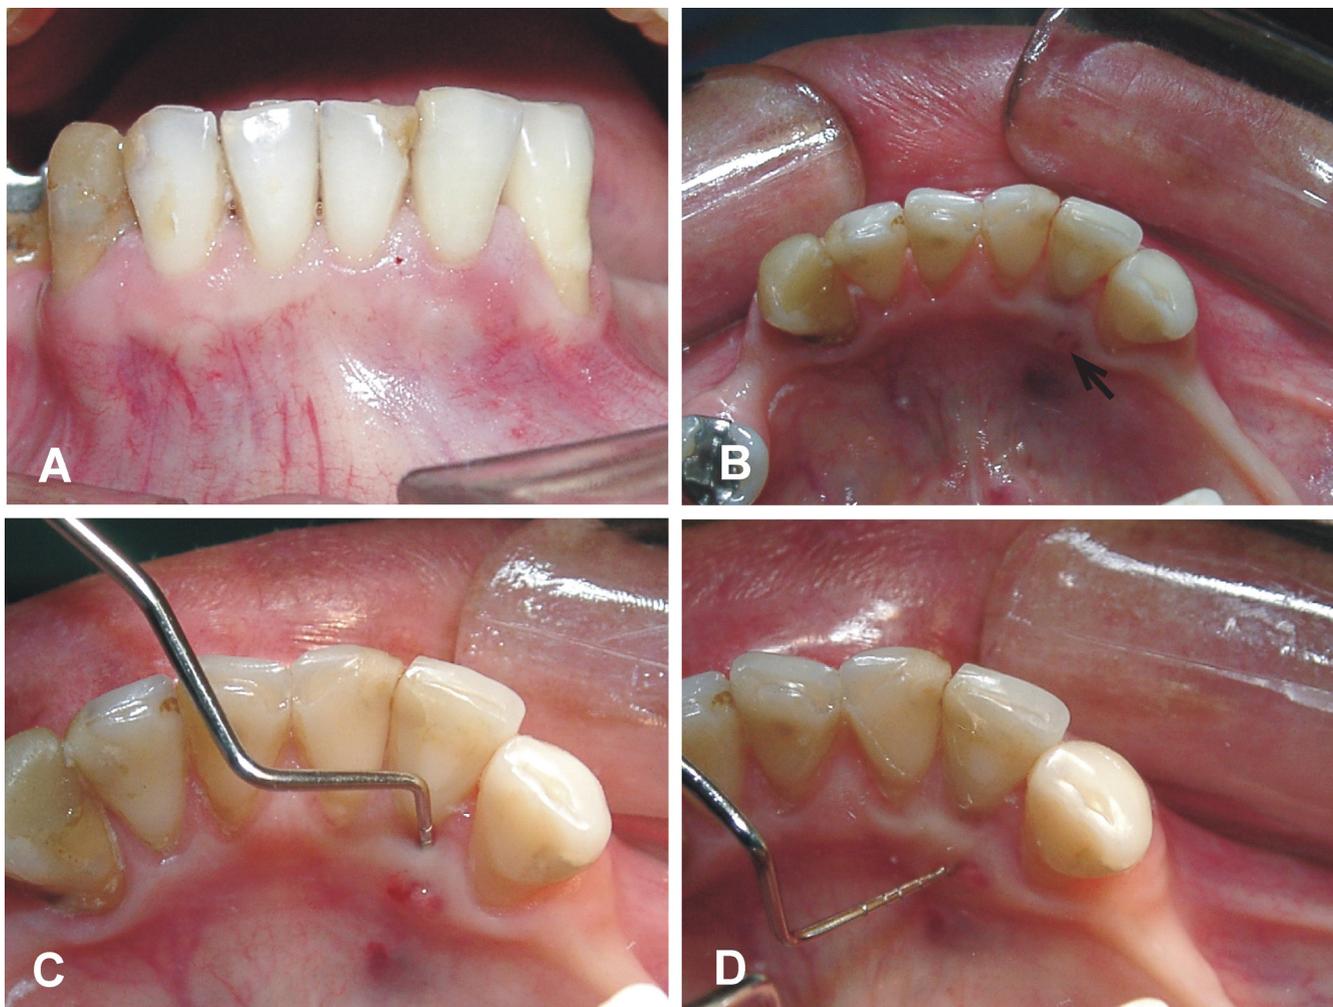
At 16 months after treatment, the patient returned with complaint of pain during mastication. Clinically, the mandibular left lateral incisor was still in supra-occlusion (Fig. 1A) and exhibited an active distolingual fistula (Fig. 1B). Periodontal probing revealed a probing depth of 9 mm on the distal aspect (Fig. 1C) and a horizontal fistula depth of 5 mm (Fig. 1D). Considering the quality of the root canal obturation (Fig. 2A), the depth of the isolated periodontal pocket and the pear-shaped distal bone loss only in this tooth (Fig. 2B), a suspected diagnosis of VRF was reached. The fistula was mapped (Fig. 2C), which confirmed that the lesion had a periodontal origin. Exploratory surgery was performed to confirm the diagnosis (Fig. 3A), and it revealed a VRF on the distolingual aspect of the root without separation of the root fragments; the tooth was extracted (Fig. 3B). The granulation tissue removed from the socket was sent for a histopathological examination (Fig. 3C). The extent of the fracture was observed after cleaning the specimen; the VRF extended from the cervical region to the apical region of tooth 32 (Fig. 3D). The histopathological diagnosis revealed a non-specific chronic inflammatory process, with a mononuclear inflammatory infiltrate and collagen deposition.

Fig. 1. Clinical examination: (A) mandibular left lateral incisor in supra-occlusion; (B) distolingual fistula (arrow); (C) periodontal pocket probing; (D) horizontal fistula probing.

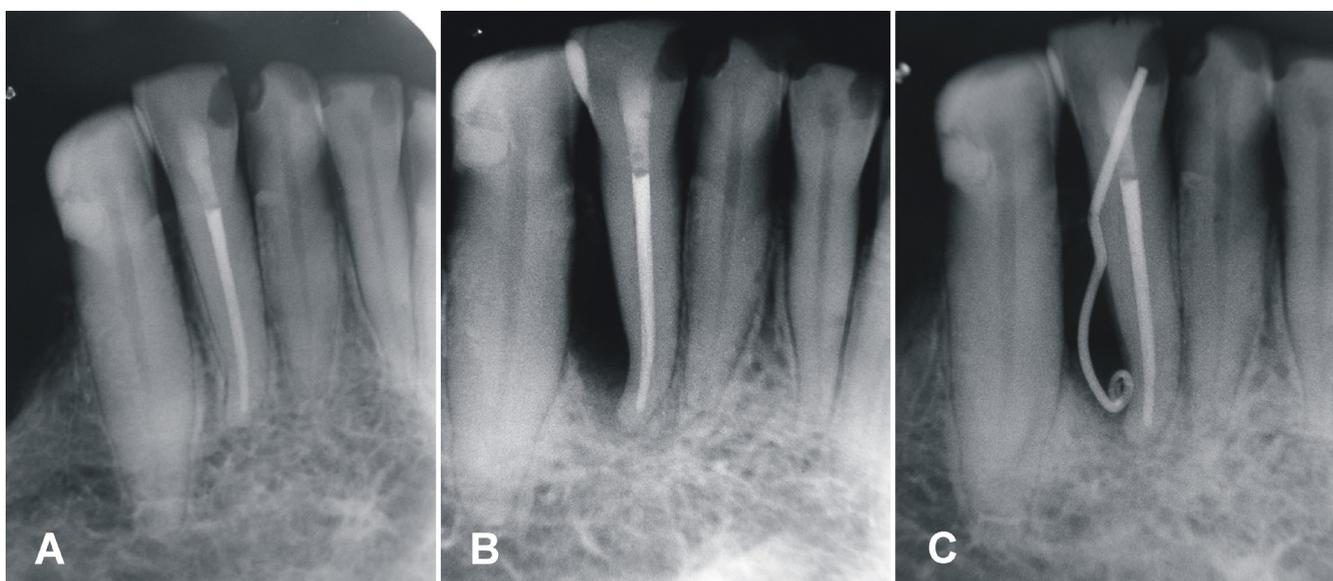
Fig. 2. Radiographic examination: (A) quality of endodontic treatment immediately after root canal filling; (B) distal radiolucent image of tooth 32; (C) mapping of the fistula.

Other diagnostic difficulties of this type of fracture are related to endodontically treated teeth because the line of fracture may be shadowed by the obturation material (4), as in the present case. The diagnostic radiographs suggested the presence of a VRF in the radiographic image, exhibiting a longitudinal radiolucent “halo” that nearly encompassed the entire distal aspect of the root, confirming the horizontal and isolated bone loss on the mandibular left lateral incisor. In addition, an occlusal adjustment was not performed after the endodontic procedure, and the tooth was still in supra-occlusion, which could be a causal factor of the VRF. Initially, this radiographic aspect was hypothetically interpreted as a sequel of chronic inflammation induced by the VRF because this finding is non-specific and might be confused with manifestations of periodontal disease or failed endodontic treatment (8).

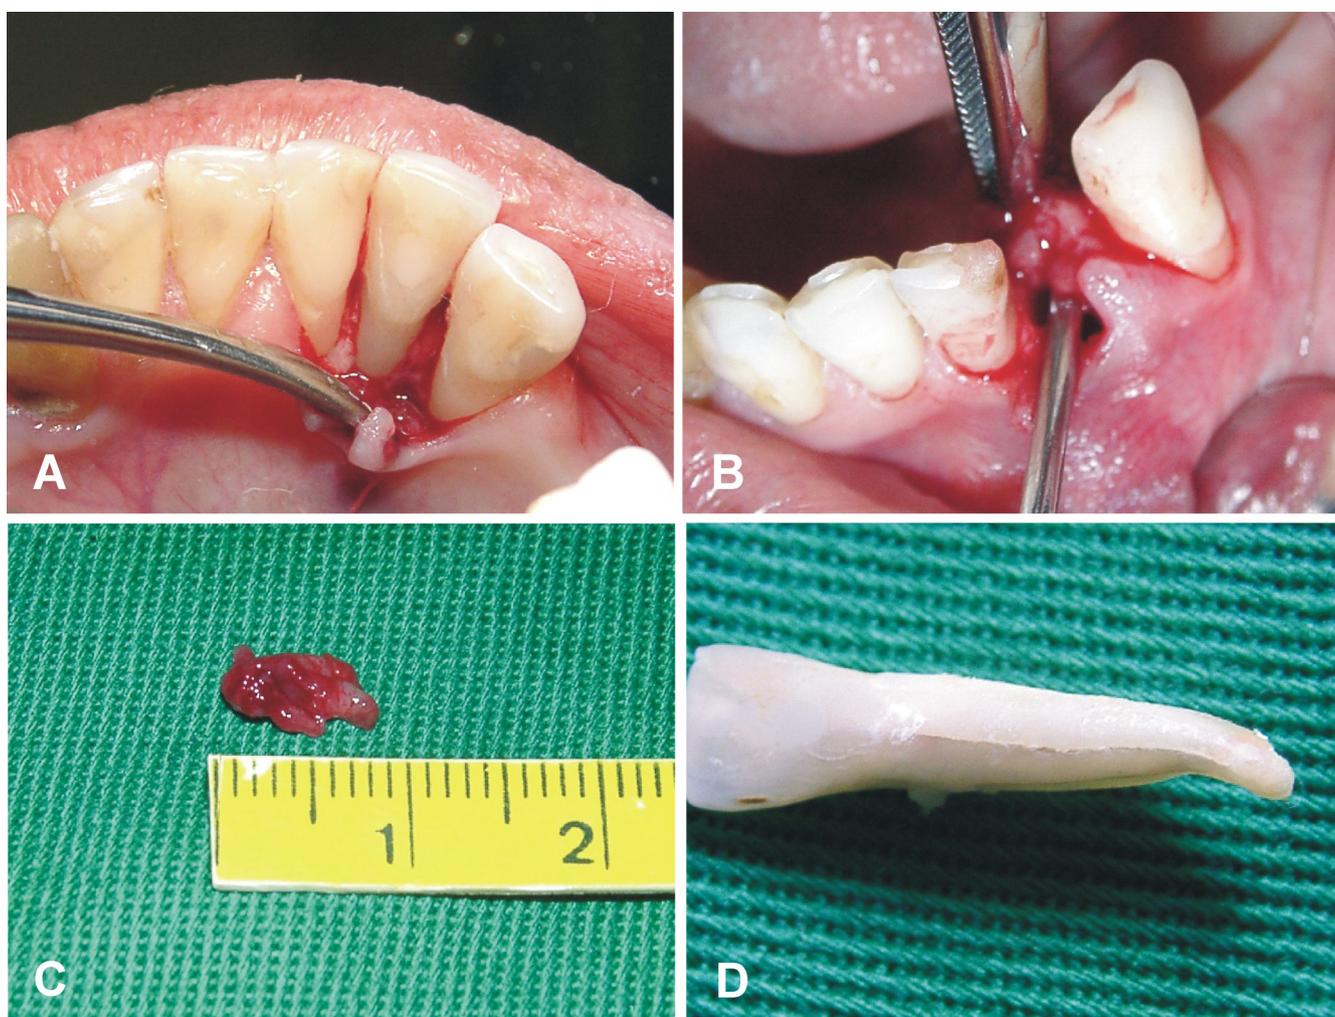
Fig. 3. Exploratory surgery: (A) surgical access; (B) extraction of mandibular left lateral incisor and socket curettage; (C) granulation tissue sent for histopathological examination; (D) extracted tooth and visualization of VRF throughout the root extent.

optical tomography is not available for dental use; it is a diagnostic unit for atherosclerotic plaques found in heart catheter laboratories and could be a valuable tool for the diagnosis of VRFs (13). Unfortunately, conventional computed tomography and cone-beam or digital volume computed tomography are not available to most of the population because of their high cost. The conventional periapical radiograph is still the most employed method, despite its low sensitivity, and this is likely due to the accessibility of low cost of X-ray machines. Furthermore, the diagnosis of a VRF is only conclusive when the affected tooth is surgically explored to visualize the fracture line (1,14,15), which was confirmed in the present case.
